# Manhole Inspection Summary

Manhole # S47GG\_043MH

Insp Date: **6/18/08 10:42 AM**

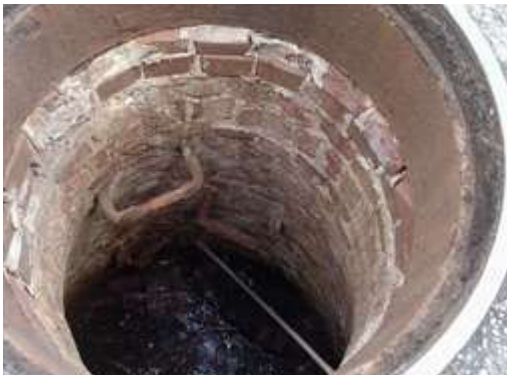
Defect 2

Condition: ☐ Sound ☐ Cracked ☐ Root Intrusion ☒ **Loose Brick** ☐ Deteriorated

loose bricks

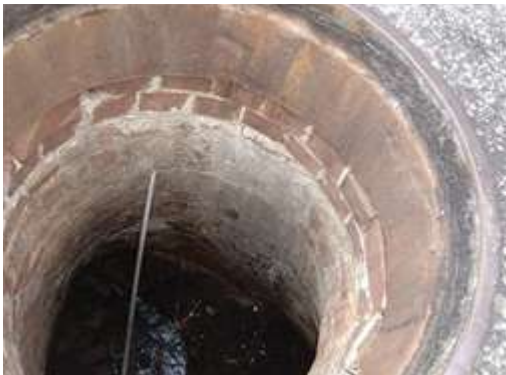
Defect 1

Infiltration: ☐ None ☒ **Joint** ☐ Cracks ☒ **Mortar** ☐ Roots ☐ Wall

Infiltration: ☐ None ☐ Joint ☐ Cracks ☐ Mortar ☐ Roots ☒ **Wall**

infiltration

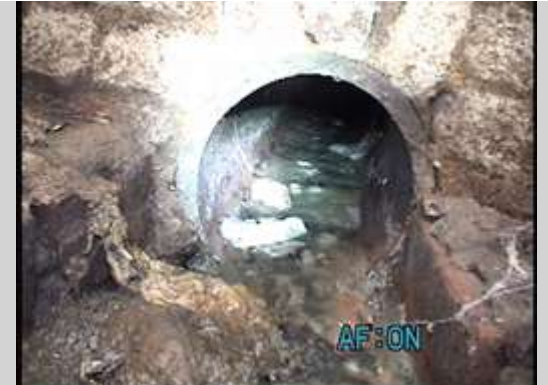
12 O'Clock Outflow

8 in. Circular Gravity Sewer  
Pipe Out @ 12 O'Clock

Pipe Height: **8.4** (in.) Rod and Bar (Angled)  
Pipe Material: **Clay** ☐ Pipe Lined  
Invert Depth: **7.85** (ft.) Flow Characteristics: **Fast**  
Deposits: ☒ None ☐ Mud ☐ Sludge ☐ Debris ☐ Grease  
Silt Depth: (in.) Deposits Extent:  
Infiltration: **None** Pipe Seal Cond: **Sound**

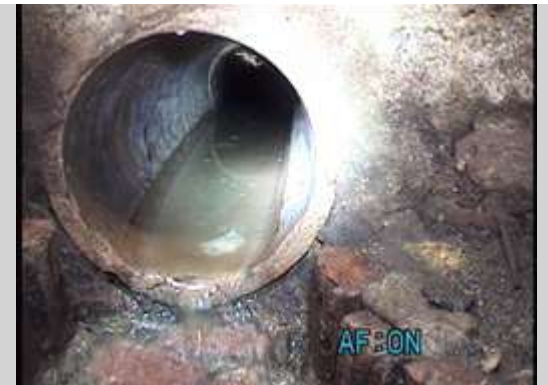
9 O'Clock Inflow

8 in. Circular Gravity Sewer  
Pipe In @ 9 O'Clock

Pipe Height: **8.4** (in.) Rod and Bar (Angled)  
Pipe Material: **Clay** ☐ Pipe Lined  
Invert Depth: **6.50** (ft.) Flow Characteristics: **Fast**  
Deposits: ☒ None ☐ Mud ☐ Sludge ☐ Debris ☐ Grease  
Silt Depth: (in.) Deposits Extent:  
Infiltration: **None** Pipe Seal Cond: **Sound**
